## **COMPLAINT INSPECTION REPORT**

Project Name:	Mountain Valley Pipeline	Inspector:	John McCutcheon
Inspection Date:	Wednesday, August 15, 2018	Project Contact:	Brian Clauto, Tracy Hilbun
Spread:	Spread I	Weather (Wet/Dry/Rain):	Dry

## FIELD INSPECTION PHOTO LOG

Project Name: Mountain Valley Pipeline Date: Wednesday, August 15, 2018

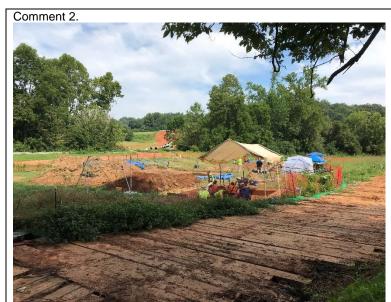
Excavation site well-protected with E&S controls and vegetated buffer.

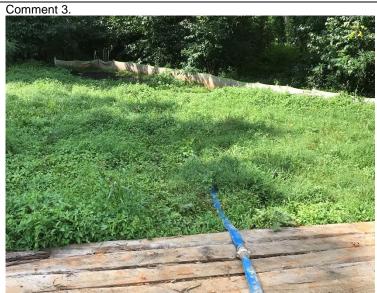
Trench dewatering hose leading to filter bag and silt fence.

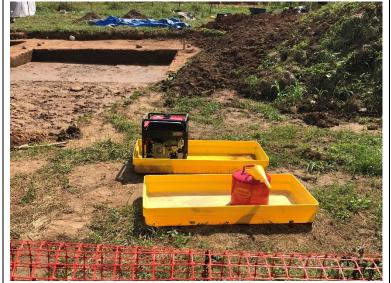
## Comment 2

Pollution prevention measures for pump and fuel.
